## Archaeological-geological observations in the Saint Roch Church

Mainly in July 2010, archaeological excavation and inspection was carried out during the demolition of certain building parts. Our aim was to support the reconstruction with the results of scientific investigations.<sup>1</sup> Starting from 2009, co-ordination meetings had been held between the Koszta József museum (Szentes) and Municipal Self-Government of Csongrád that financed the renovation of the church. These meetings had to decide the extent of the archaeological and heritage preservation activity, the extent to which different scientific research methods could be used. Originally, we planned the almost complete excavation of the church's interior and proposed also to make test trenches around the building, to seek answers to the following questions: how big was the church cemetery and how can it be dated; is there any kind of a ditch or fence around it; what is the chronological and spatial relationship between the cemetery and the church? Does the ecclesiastical building in the Saint Roch Square have an architectural antecedent; how did the inhabitants of Belsőváros (Inner Town) use the area in question d

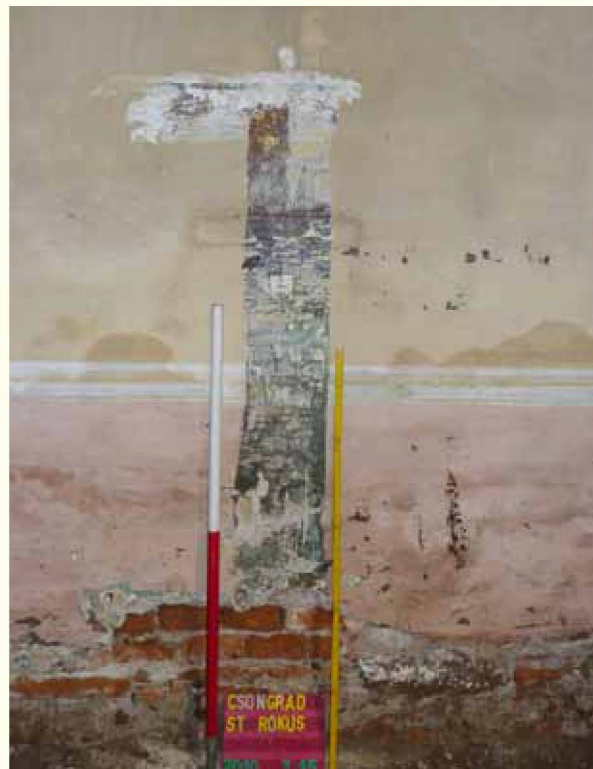
The foundation of the sacristy runs on 82.49 MbF level. That means that the wall, taking into consideration the exterior construction ground surface, is about 60 cm, not reaching the frost line, its foundation mortar is solid. It seems that similarly to the foundation of the church, the foundation of the sacristy also carried the mass of this building part, transmitting well the burden to the soil. The wall stands on a trampled black marshy subsoil, so it has to be well protected from

water. Macroscopically, the wall of the sacristy and the nave are very similar.

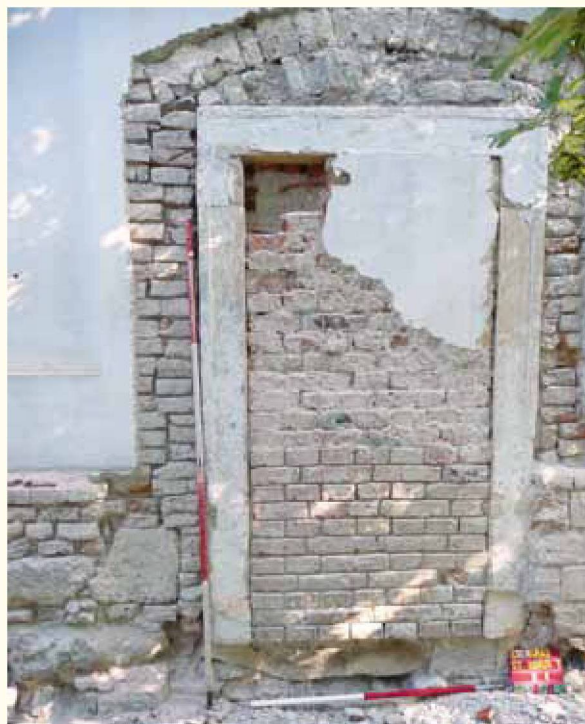
In the eastern wall of the chancel, in the exterior side, under the plastering the trace of a window filled with a single row of bricks can be seen. Opposite it, in the interior side of the wallwork, behind the high altar, a 90 cm wide windowcase of Gothic character can be seen. It strongly narrows towards the exterior side and is 50 cm lower and 12–13 cm wider than the rest of the windows.

The inner sides of the window narrowing splayed outwards, were painted a greenish-ochre. Its inner edge was emphasised with a 5-cm-wide red frame, while its splayed parapet with red paint. The narrowing and elongating, that is to say, remodelling of the earlier windows explains why the windowcases and sections of wallwork in the exterior of the chancel do not harmonise.

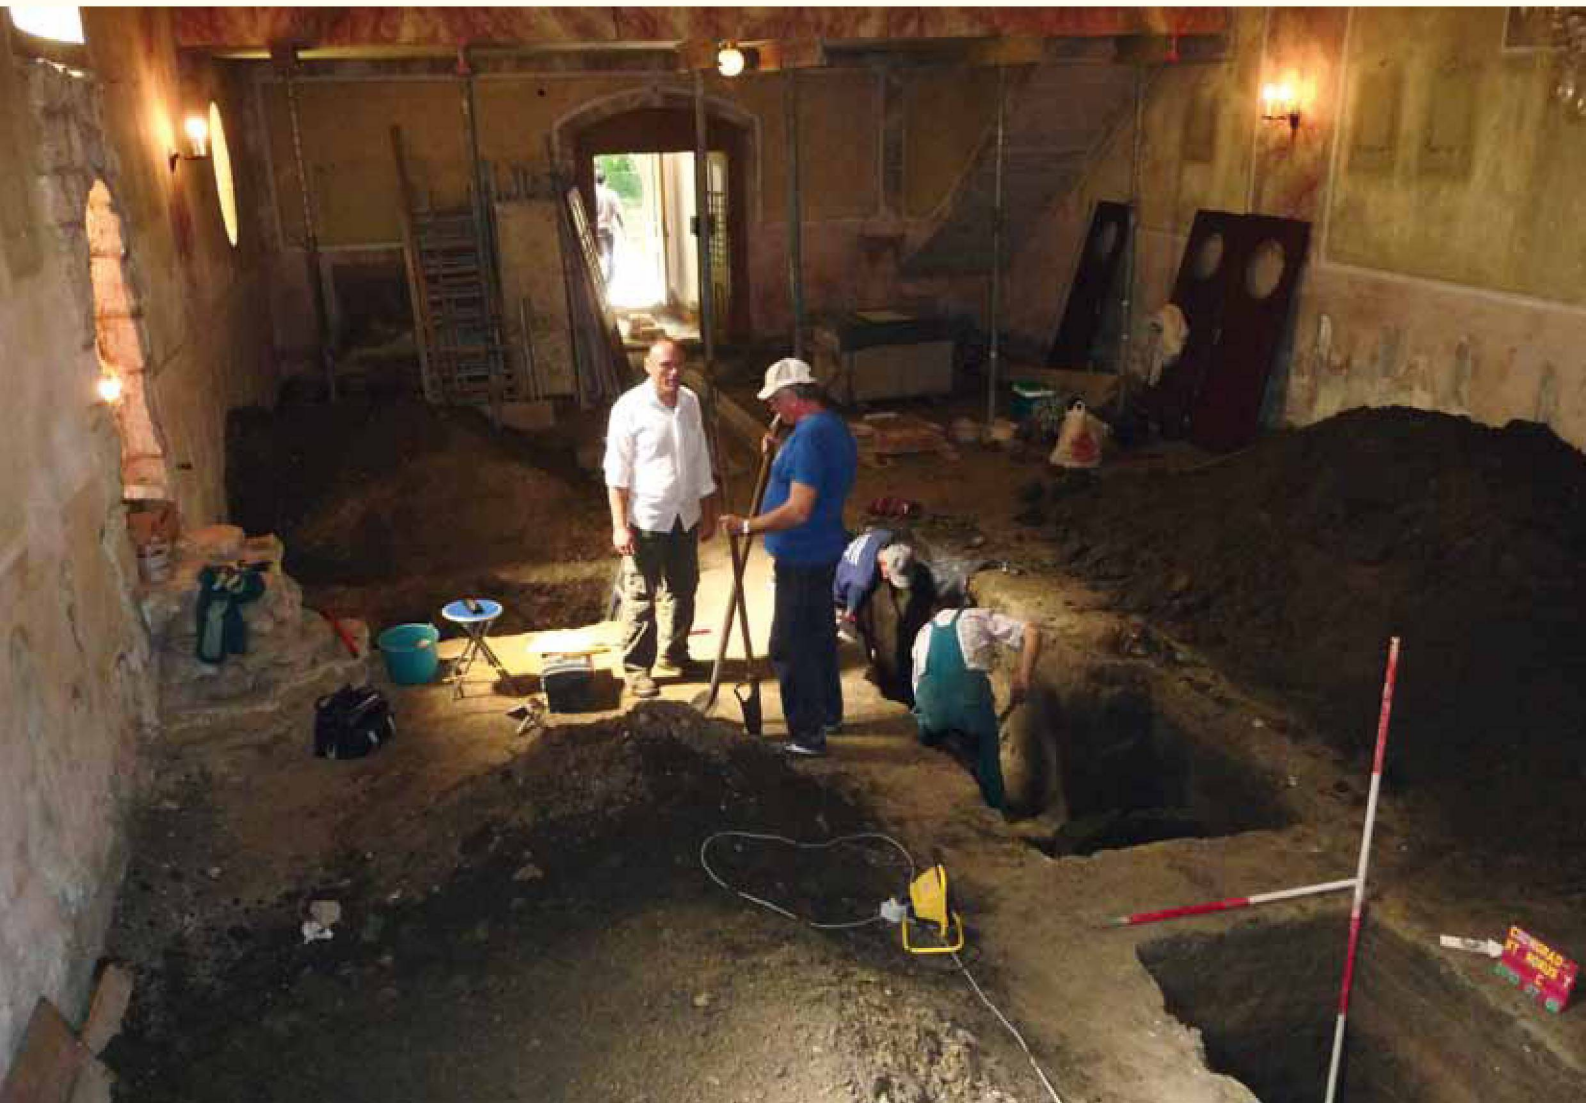
Small fragments of glazed and unglazed, red and white clay vessels came to light from the fill of the pit in the centre of the church. Of special interest is a wheel-made, yellowish-brown and green lead-

glazed bowl fragment. This deep vessel with flat bottom and wide vertical rim, made of white clay was decorated with variation of yellowish-brown and green glaze colours separated with incisions.

This bowl is similar to a special type of vessels decorated with etched motifs and glaze.<sup>14</sup> Similar fragments of bowls and jugs are known from the excavation of the old church and the northern block of the house in Bocskai Street, Hódmezővásárhely.<sup>15</sup> On the basis of the latter, material of the pit found under the floor of the church can be tentatively dated to the second half or end of the 17<sup>th</sup> century.
